Major Article

# Unseen threats: Lumens 2.0 study reveals the hidden challenges of cleaning lumened surgical instruments

**Methods:** Borescopes were used to inspect lumens of instruments used for orthopedic, neurologic, or earnose-throat procedures. Whenever visible soil or debris was observed, the instrument was recleaned up to 3 times and reinspected to assess the impact of additional cleaning.

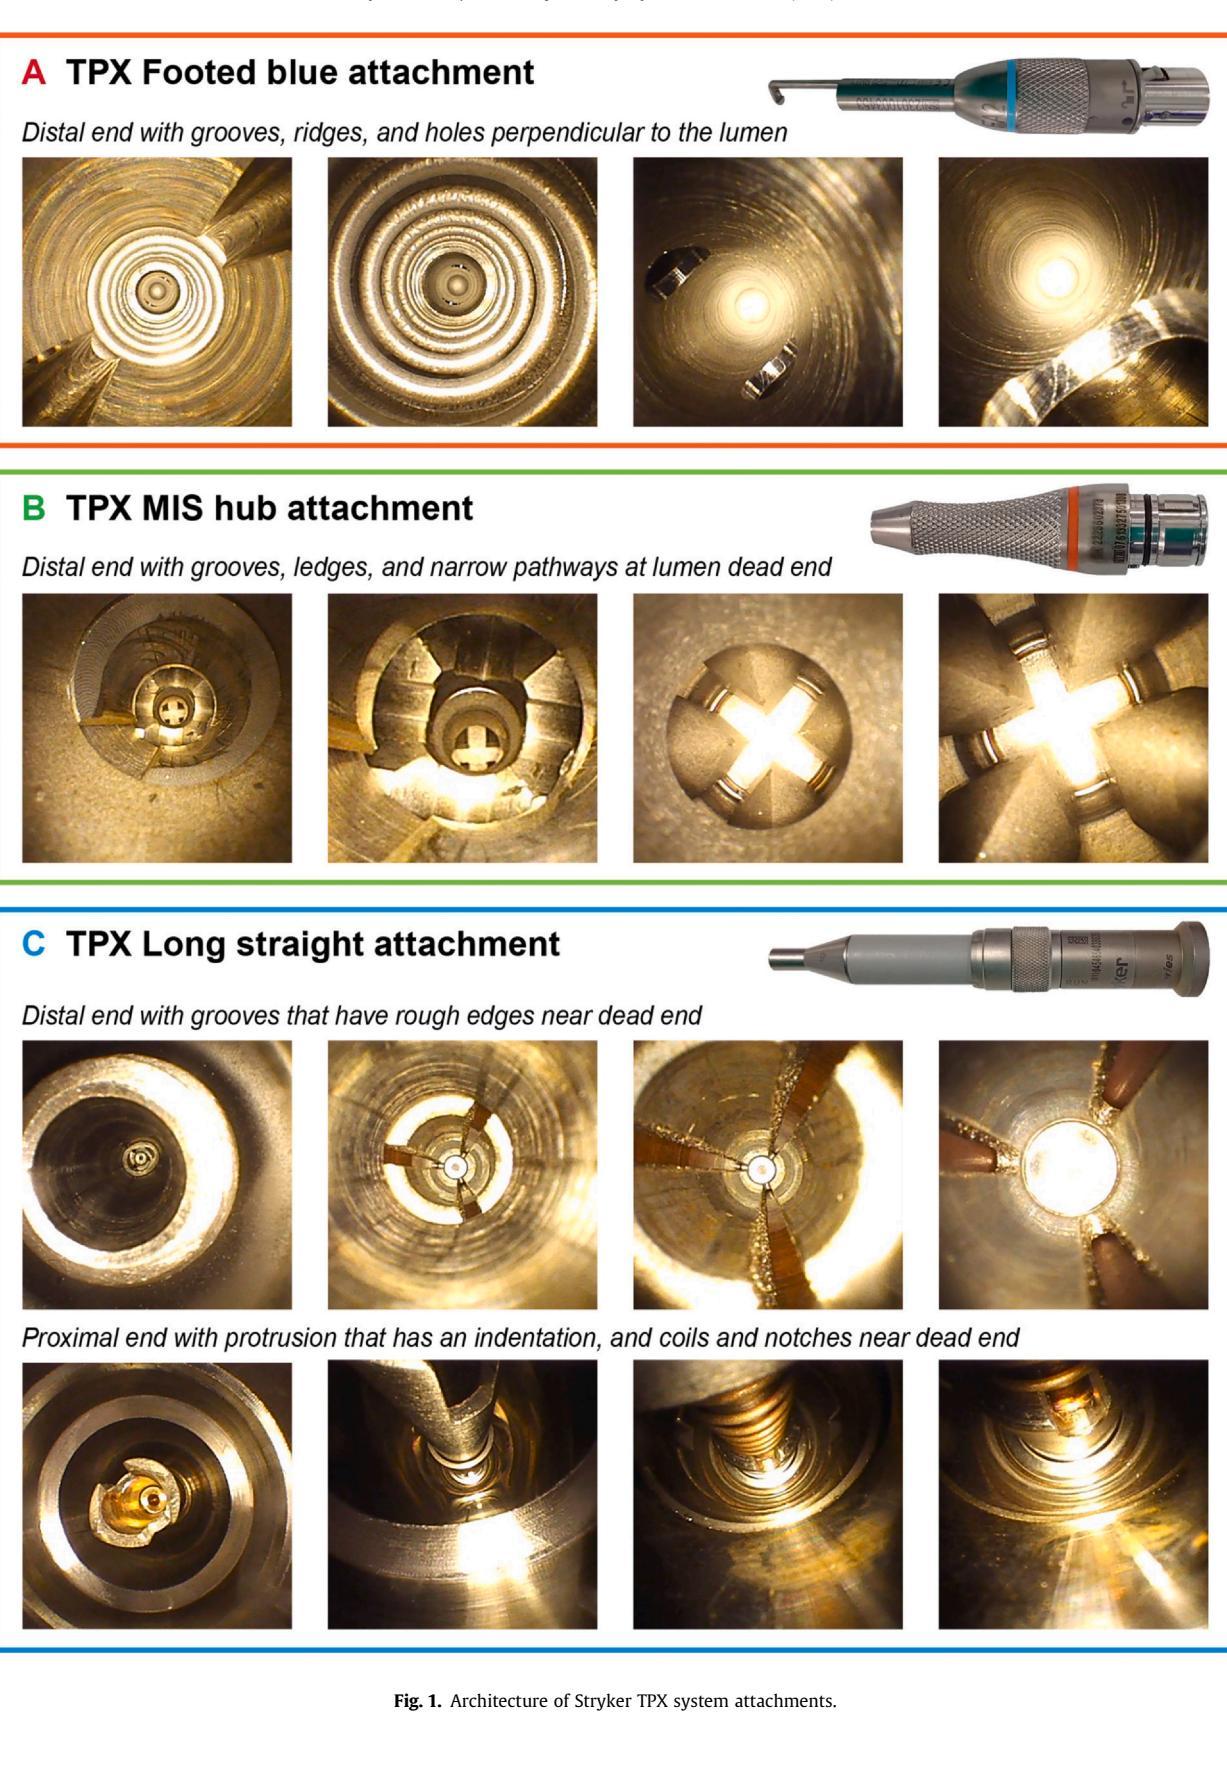
All of the instruments had architectural features that impede access by brushes and prevent visualization during the cleaning process. Lumen diameters within an instrument varied significantly between instruments and frequently changed within an instrument, with grooves parallel to the lumen and multiple ridges and ledges perpendicular to the lumen (Fig. 1).

For example, the TPX-footed blue attachment lumen passed all the way through the instrument and had multiple ridges and ledges that changed the lumen diameter, 2 shiny, smooth grooves parallel to the lumen, and holes perpendicular to the lumen that appeared to lead to cavities not accessible by the borescope (Fig. 1A). Many of the lumens terminated in dead ends with grooves or O-rings around the edge of the terminal surface. The TPX MIS hub had several ledges and a groove parallel to the lumen that appeared to have space underneath the edges. The lumen terminated in a dead end with 4 C.L. Ofstead et al./American Journal of Infection Control xxx (xxxx) xxx-xxx

rectangular columns on top of what appeared to be an O-ring (Fig. 1B). The TPX long straight attachment had 2 lumens terminating in dead ends. The distal end lumen had multiple ridges and ledges, with 3 grooves parallel to the lumen that appeared to have rough edges and a copper-colored surface (Fig. 1C).

The proximal end had a complex structure (shaft) protruding into the center of the lumen. This shaft had a depressed area on top, and it was larger in diameter near the lumen entrance than further into the lumen. There was a copper-colored coil near the dead end, with a notch perpendicular to the lumen that appeared to have an interior surface (Fig. 1C).

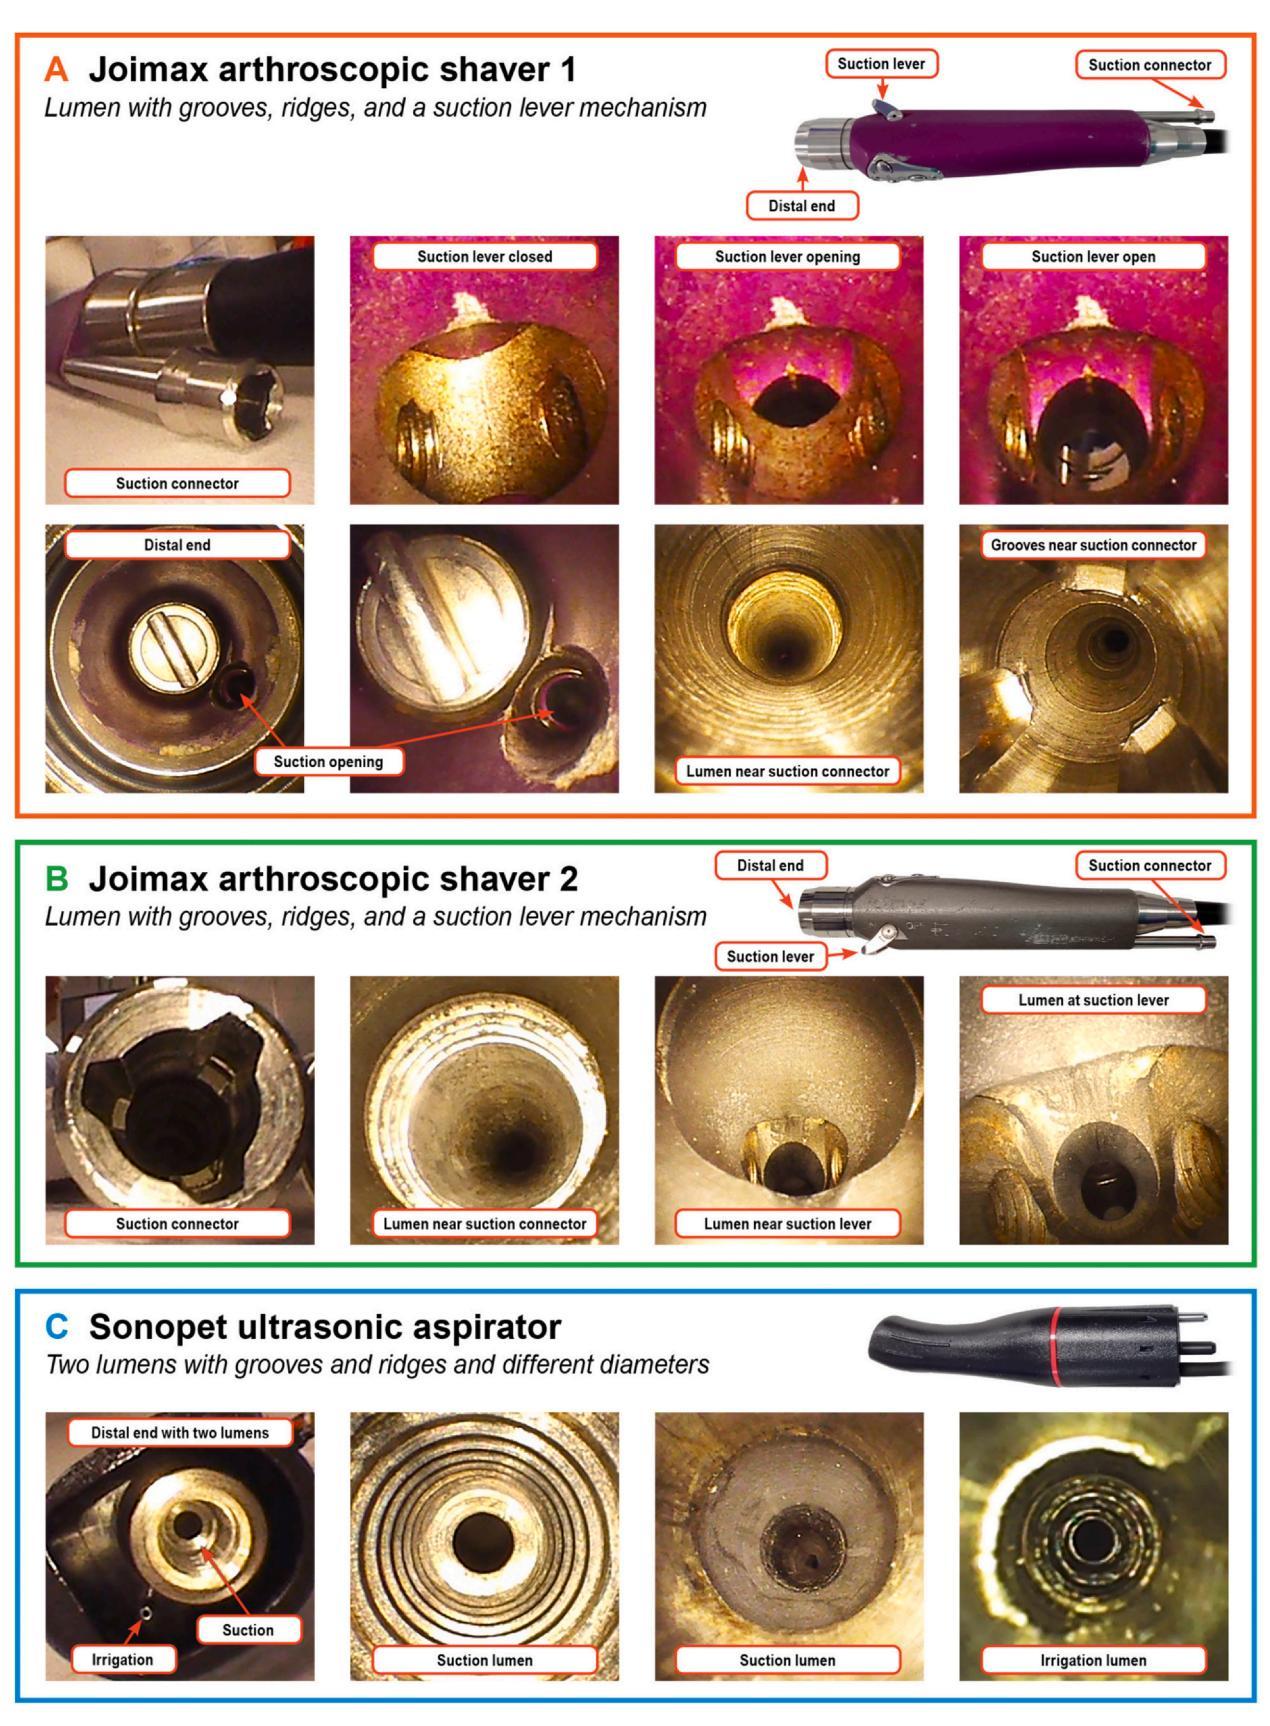
Fig. 2. Architecture of arthroscopic shavers and an ultrasonic aspirator.

The 2 Medtronic Joimax arthroscopic shavers appeared different from each other (Fig. 2). Some lumen segments of Shaver 1 were purple, and it had a suction control valve that should be rotated during cleaning (Fig. 2A). The valve body had 2 holes perpendicular to the lumen. The lumen exited the distal end in a deep cavity, and it was challenging to insert the borescope through the distal end because the lumen exit was difficult to see and access (Fig. 2A, distal end). There were 3 smooth grooves parallel to the lumen near the suction connector. The lumen of Shaver 2 also had ledges and ridges, with rough, swirly surfaces and holes perpendicular to the lumen near the suction lever (Fig. 2B). The Stryker Sonopet ultrasonic aspirators had 2 lumens. The suction lumen was much larger than the lumen used for infusing irrigation fluid into the surgical site (Fig. 2C). Both lumens had multiple ledges and ridges that changed the diameter.

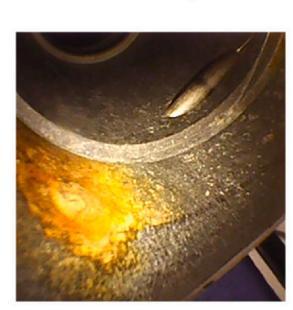
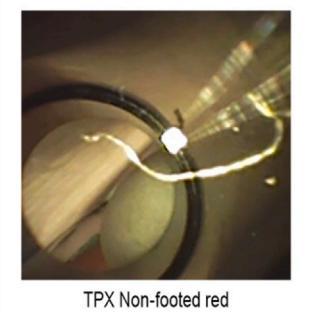
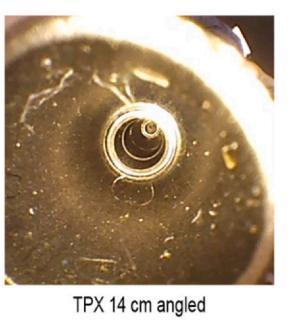
Fig. 3. Defects observed inside surgical instruments.

Researchers observed multiple defects inside lumens of 100% of instruments (Table 1). During initial inspections, scratches were seen inside 95% (38/40) of instruments and the reciprocating saws had eroded O-rings in the electrical connectors (Fig. 3A). All instruments had discolored surfaces. Brown, rust-colored, or orange patches were visible in 95% (38/40), black discoloration was observed in 60% (24/40), and 33% (13/40) had white residues that appeared to be "water spots" or detergent residue (Fig. 3B). Visible debris was apparent in 100% of instruments, with brown, yellow, orange, or white chunks in 88% (35/40) and black chunks in 38% (15/40). Fibrous debris that appeared to be lint or brush bristle fragments was observed in 73% (29/40) (Fig. 3C).

All 3 shavers were removed from service following the initial inspection. The remaining instruments were sent back to the decontamination area for additional cleaning based on the presence of discoloration or debris (Table 1). Researchers reinspected 75% (30/40) instruments after 1 round of recleaning, 72.5% (29/40) instruments after 2 rounds of recleaning, and 45% (18/40) instruments after 3 rounds of recleaning.

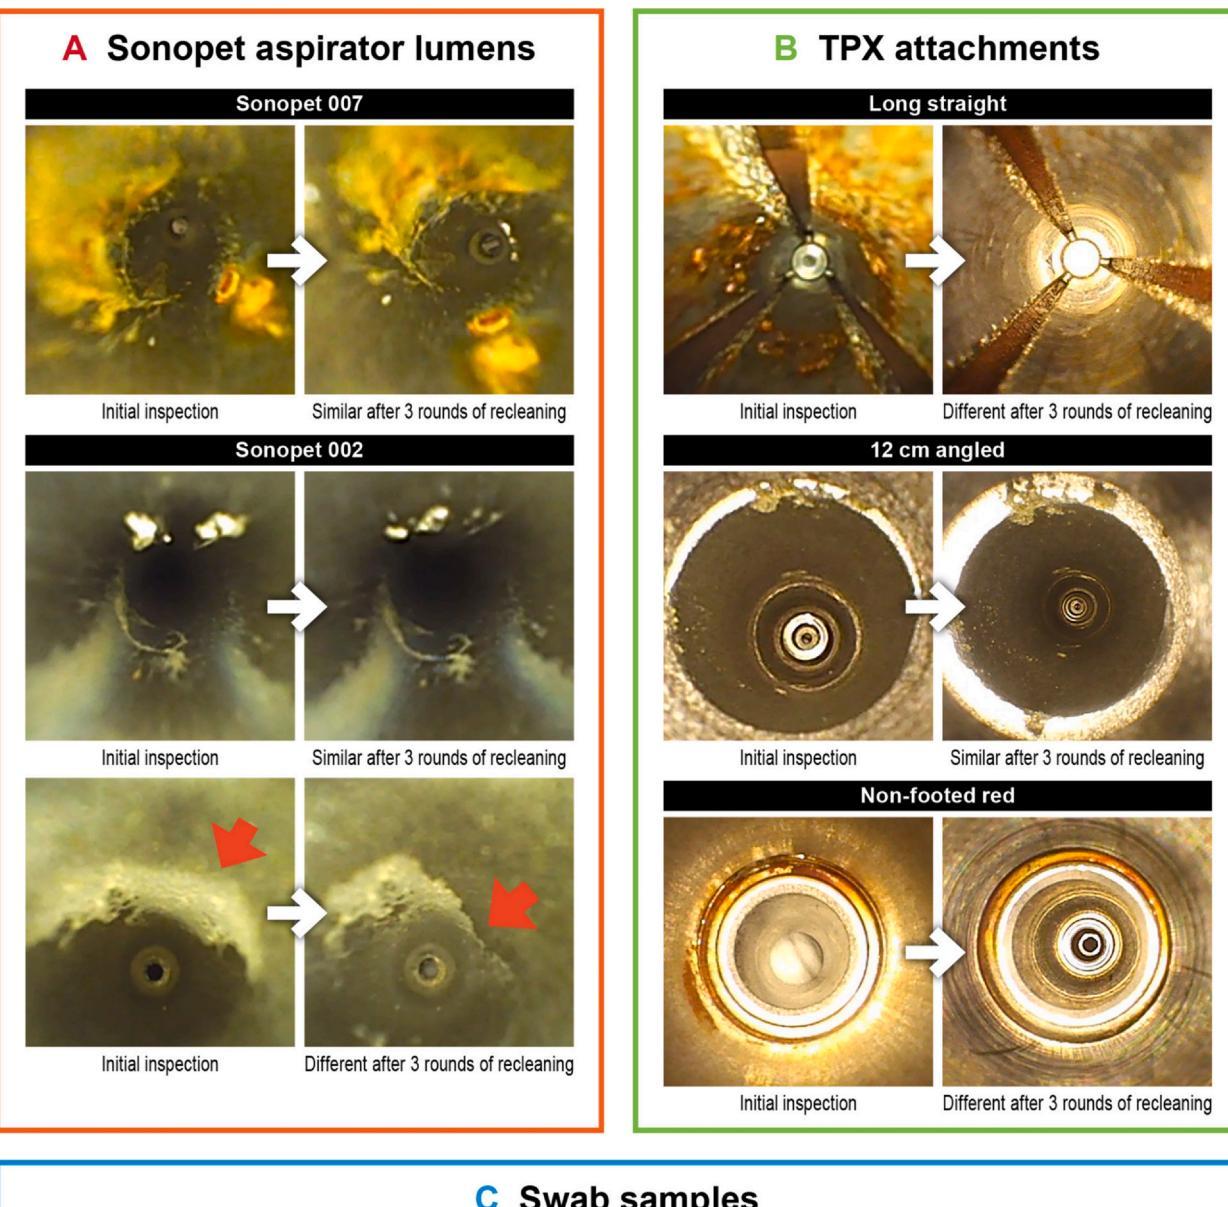
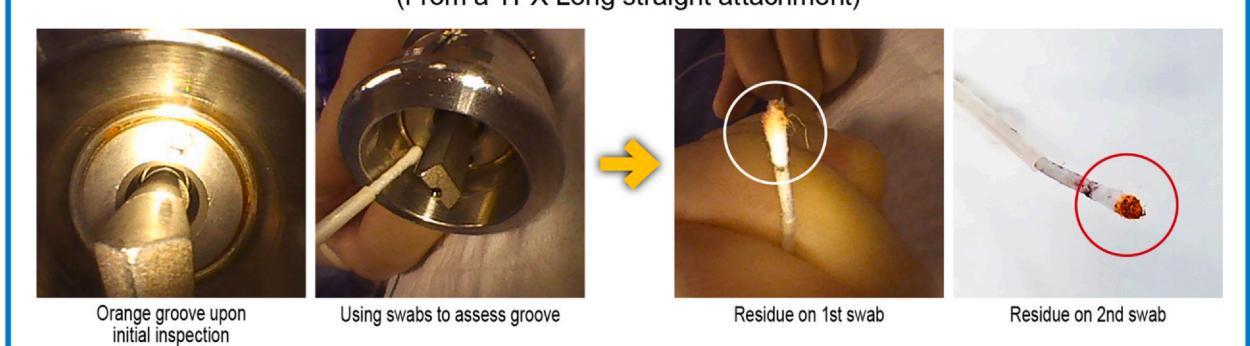
Fig. 4. Impact of recleaning on visible soil.

The irrigation lumens of both Sonopet aspirators had patches of yellow and orange debris that remained through 3 rounds of recleaning (Fig. 4A). One patch of yellow debris in the irrigation lumen of Sonopet 002 changed, with a chunk missing after the third recleaning (Fig. 4A). Recleaning of TPX attachments had variable impact. For a long straight attachment, most of the rust-colored residue and yellow debris disappeared after the third round of cleaning (Fig. 4B). In contrast, yellow debris was still present on a ledge of a 12-cm angled attachment after repeated recleaning. During recleaning of the TPX attachments, researchers also discovered that certain dead-end lumens were not completely occluded as initially thought. In some cases, water and air were still able to pass through specific sections of the complex designs, indicating partial patency.

In most instruments, there was orange or brown discoloration around a groove at the lumen's dead end. It was not fully removed by recleaning and commonly remained unchanged (Fig. 4B, nonfooted red attachment). Researchers investigated further to discern whether these grooves contained removeable residues. Sterile 1-mm swabs were used to rub surfaces under borescope guidance. The swabs turned orange or had black or brown particles embedded on the swab (Fig. 4C). Swabs were also used to remove other residues, and in almost every case, there was visible soil on the swab. Researchers observed that technicians would not have been able to reach these areas with brushes because instrument architecture prevented access without using a borescope to guide movements when cleaning.

### C Swab samples (From a TPX Long straight attachment)

Recleaning was never completely effective, and 100% of instruments still had discoloration or debris after recleaning. In some cases, recleaning removed soil or debris, but new fragments of fibrous debris were visible upon repeat inspection. This new debris appeared to be lint or brush bristles. Droplets of fluid were observed inside several instruments that had been recleaned and dried using forced air prior to reinspection.
